Redevelopment of Lyons Falls Mill Joint Agency Public Meeting

FERC Project No. 2548

March 4, 2015

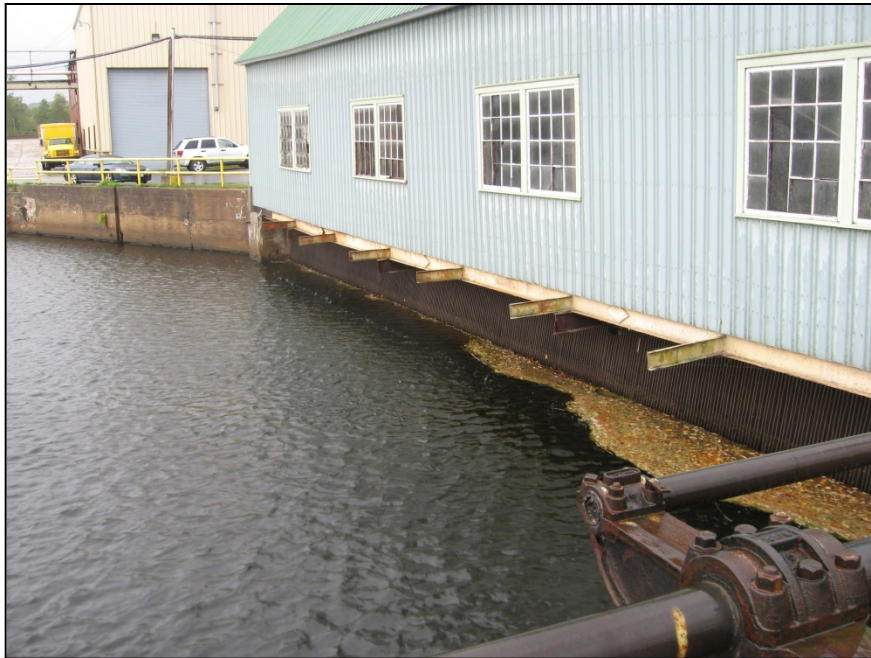
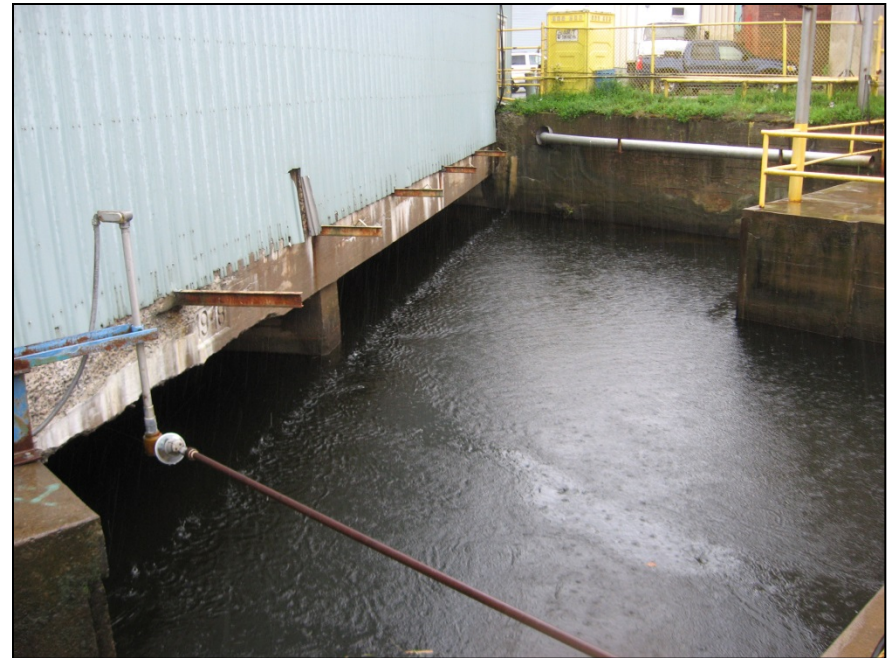
- The intake structure is located adjacent to the river left dam abutment and is equipped with trashracks measuring 18 feet high and 89 feet wide.
- The trashracks have a clear bar spacing of 1 and 7/8 inches.
- The intake area also includes a 3.75-foot-wide by 6-foot-high manually operated bottom-opening debris gate.

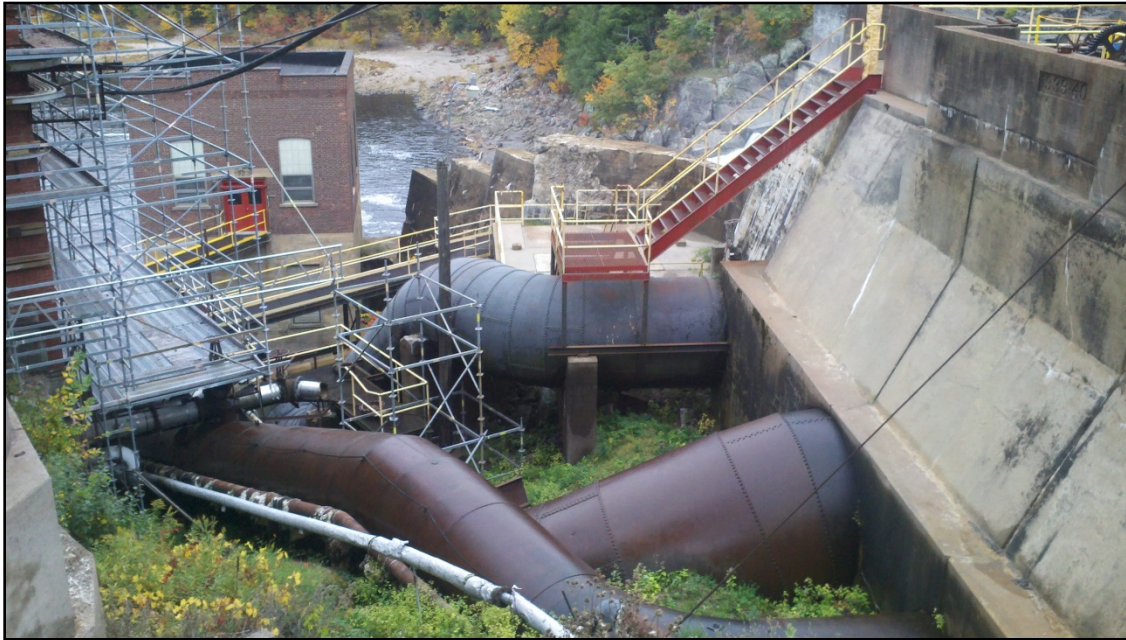
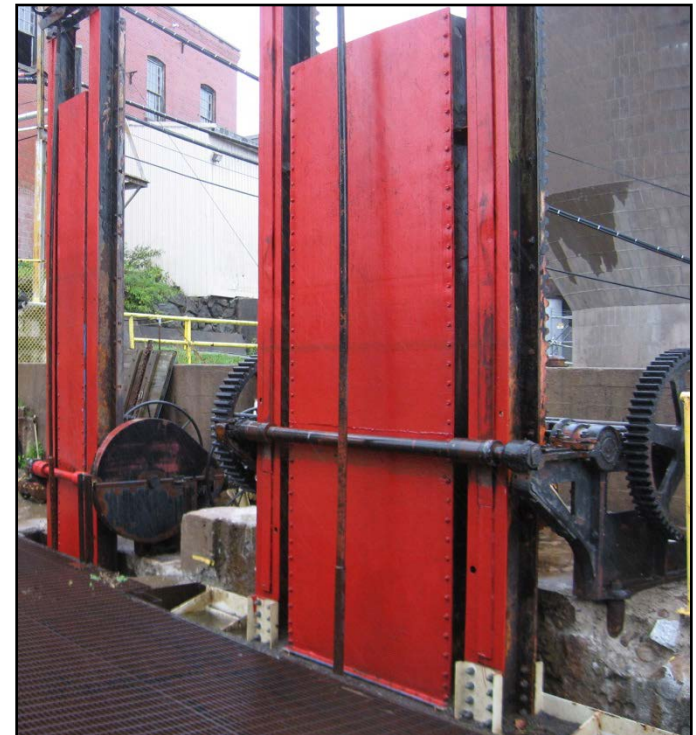
- The intake structure feeds three penstocks that lead to two powerhouses.
- Each penstock has an individual, manually operated intake gate.
- Existing generating equipment at Lyons Falls Mill is housed within two powerhouses located on river left.

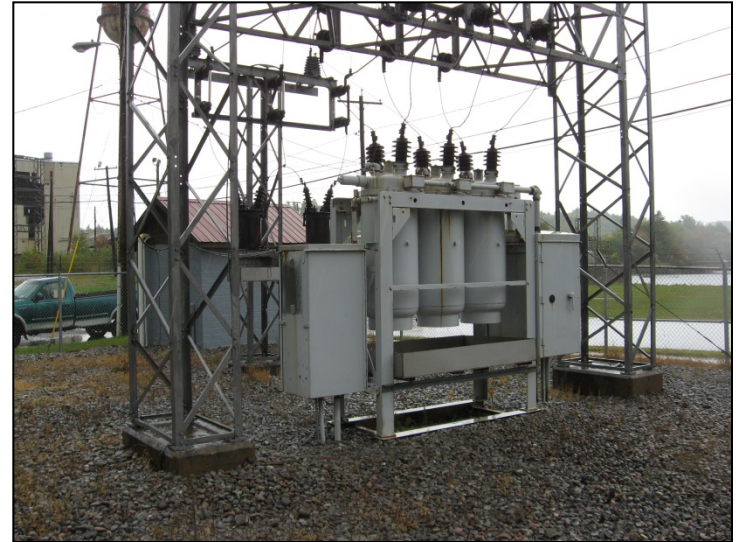
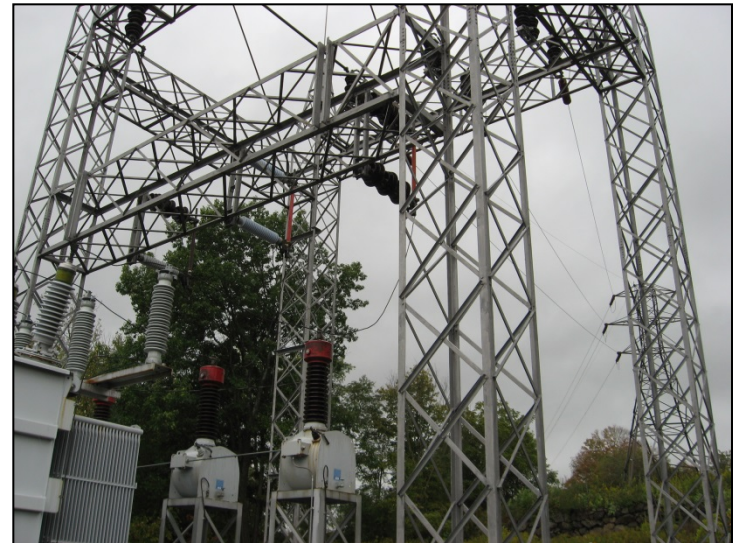
- 5 kV generator leads will extend from the new powerhouse to a new 15 MVA generator step-up (GSU) transformer to be located near the new intake structure.
 - The GSU will step-up generation voltage from 4.16 kV to the distribution voltage of 23 kV.
- A new 23 kV aerial transmission line will replace the existing overhead line and will extend 2,640 feet from the GSU transformer to the existing circuit breaker for Lyons Falls Mill.
- The existing overhead conductors will extend from the existing circuit breaker to the utility point of interconnection at the existing National Grid transformer in the Franklin Street Substation.

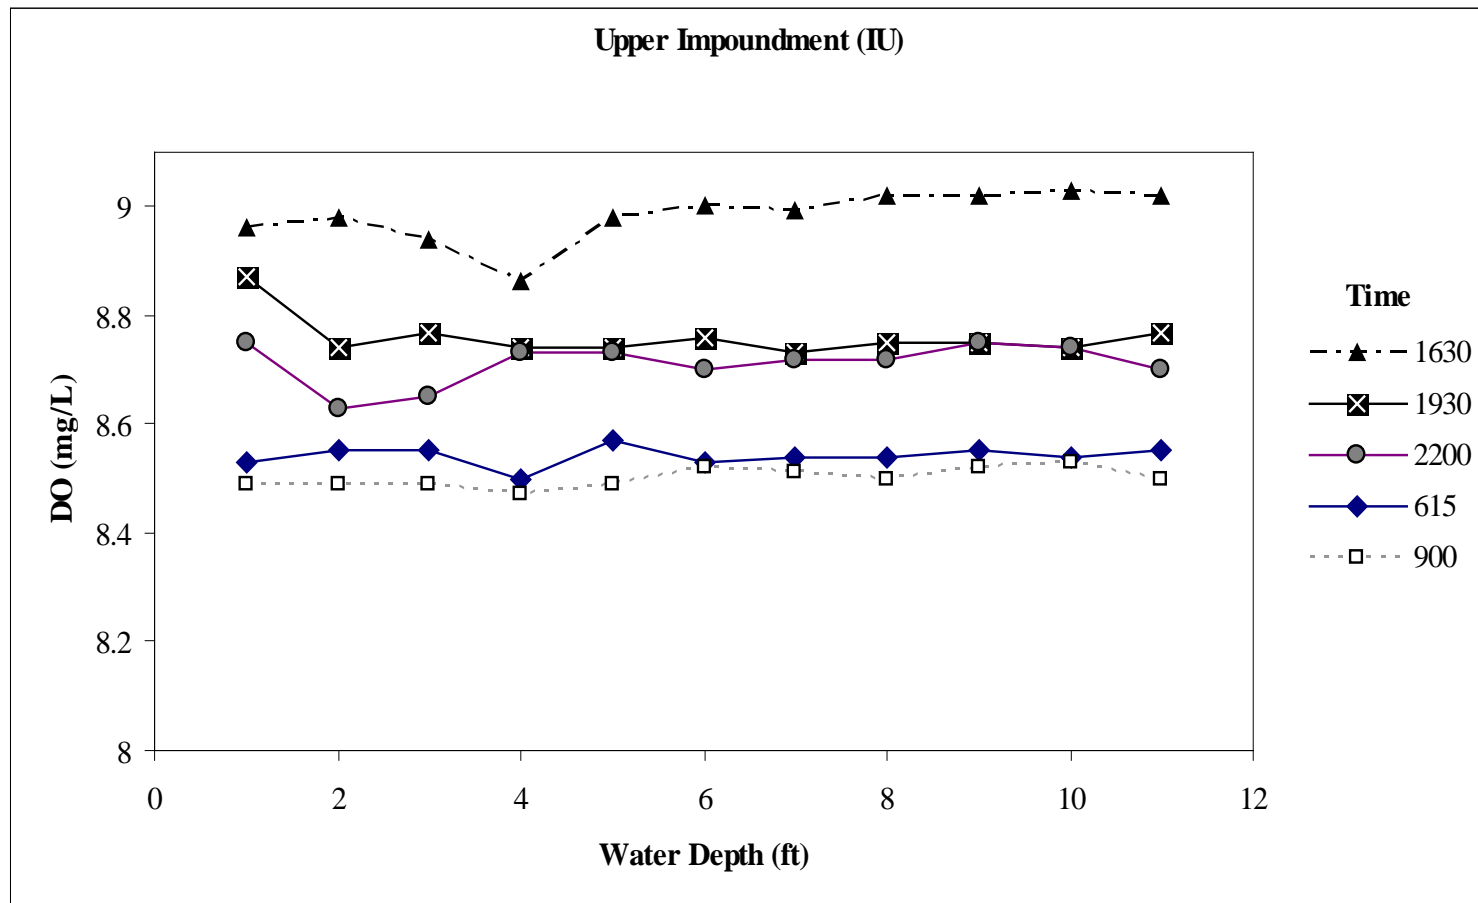
DISSOLVED OXYGEN BY DEPTH AND SAMPLING TIME IN THE UPPER IMPOUNDMENT

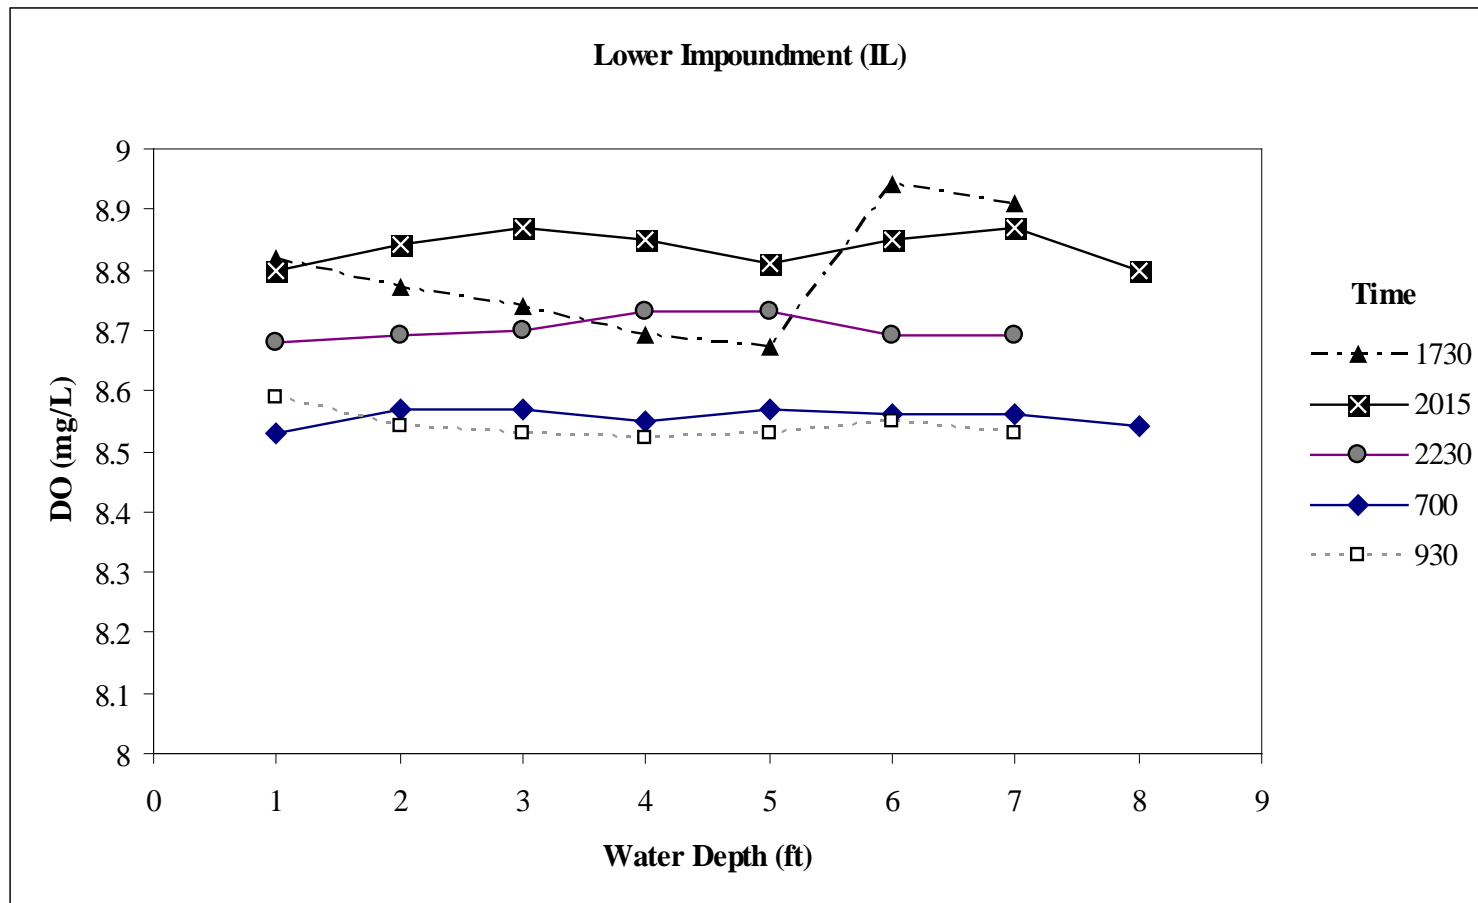
DISSOLVED OXYGEN BY DEPTH AND SAMPLING TIME IN THE LOWER IMPOUNDMENT

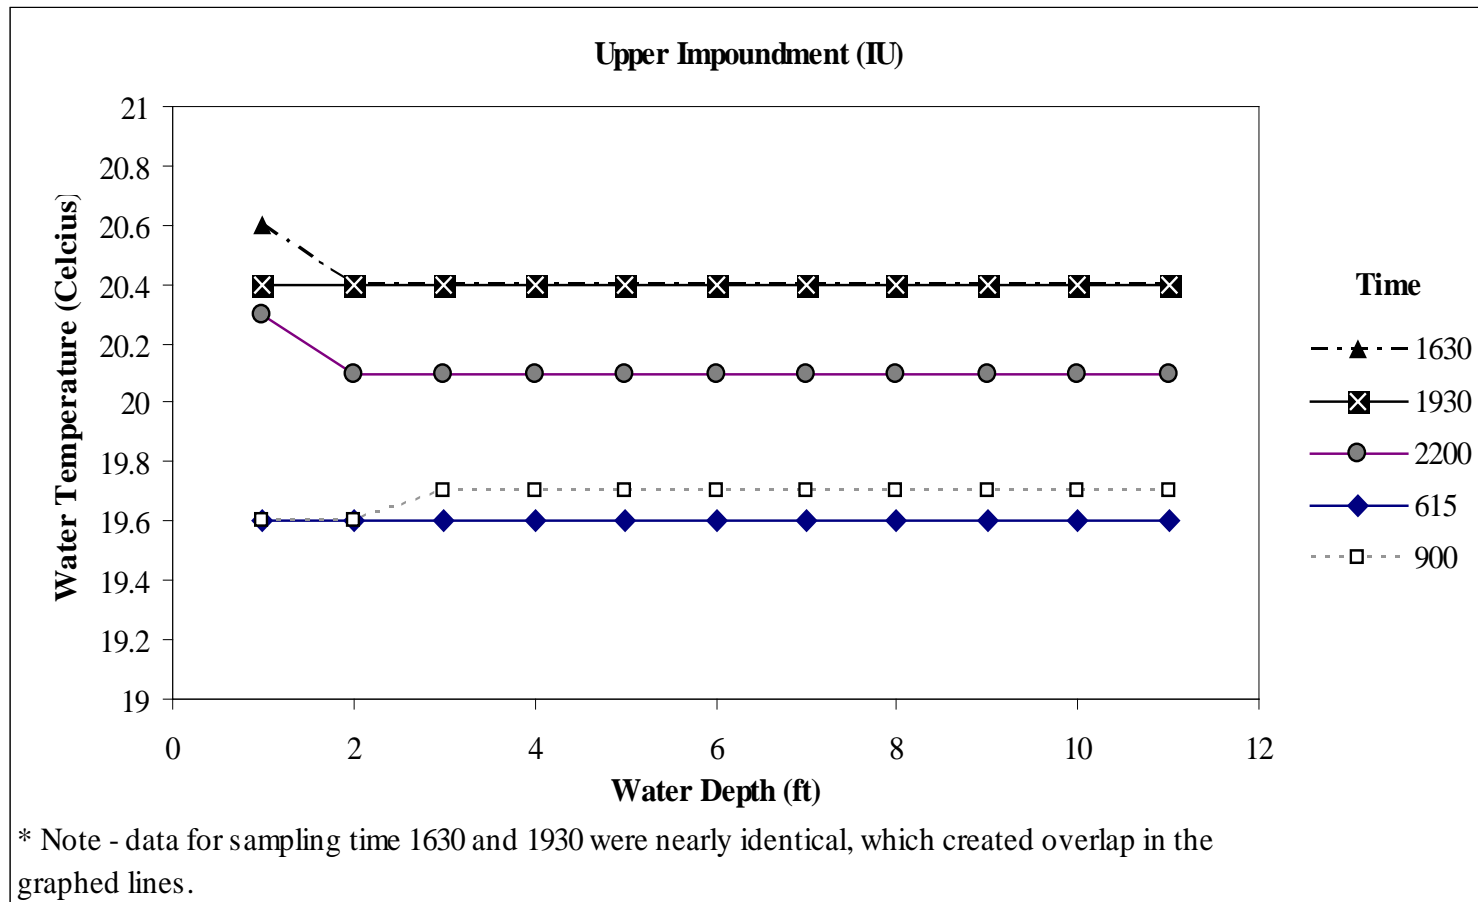
WATER TEMPERATURE BY DEPTH AND SAMPLING TIME IN THE UPPER IMPOUNDMENT

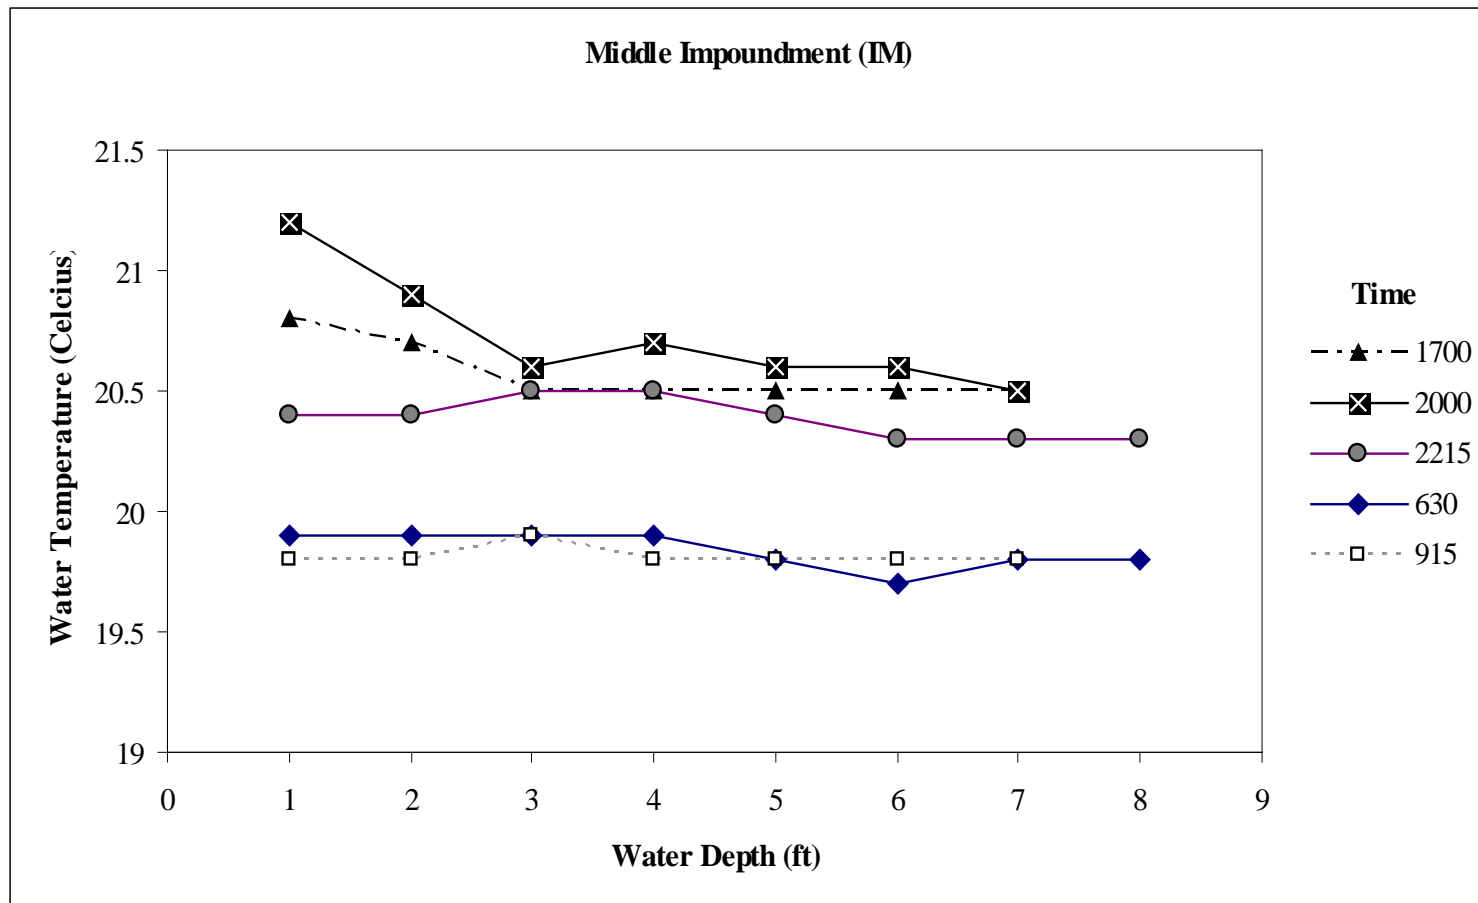
WATER TEMPERATURE BY DEPTH AND SAMPLING TIME IN THE MIDDLE IMPOUNDMENT

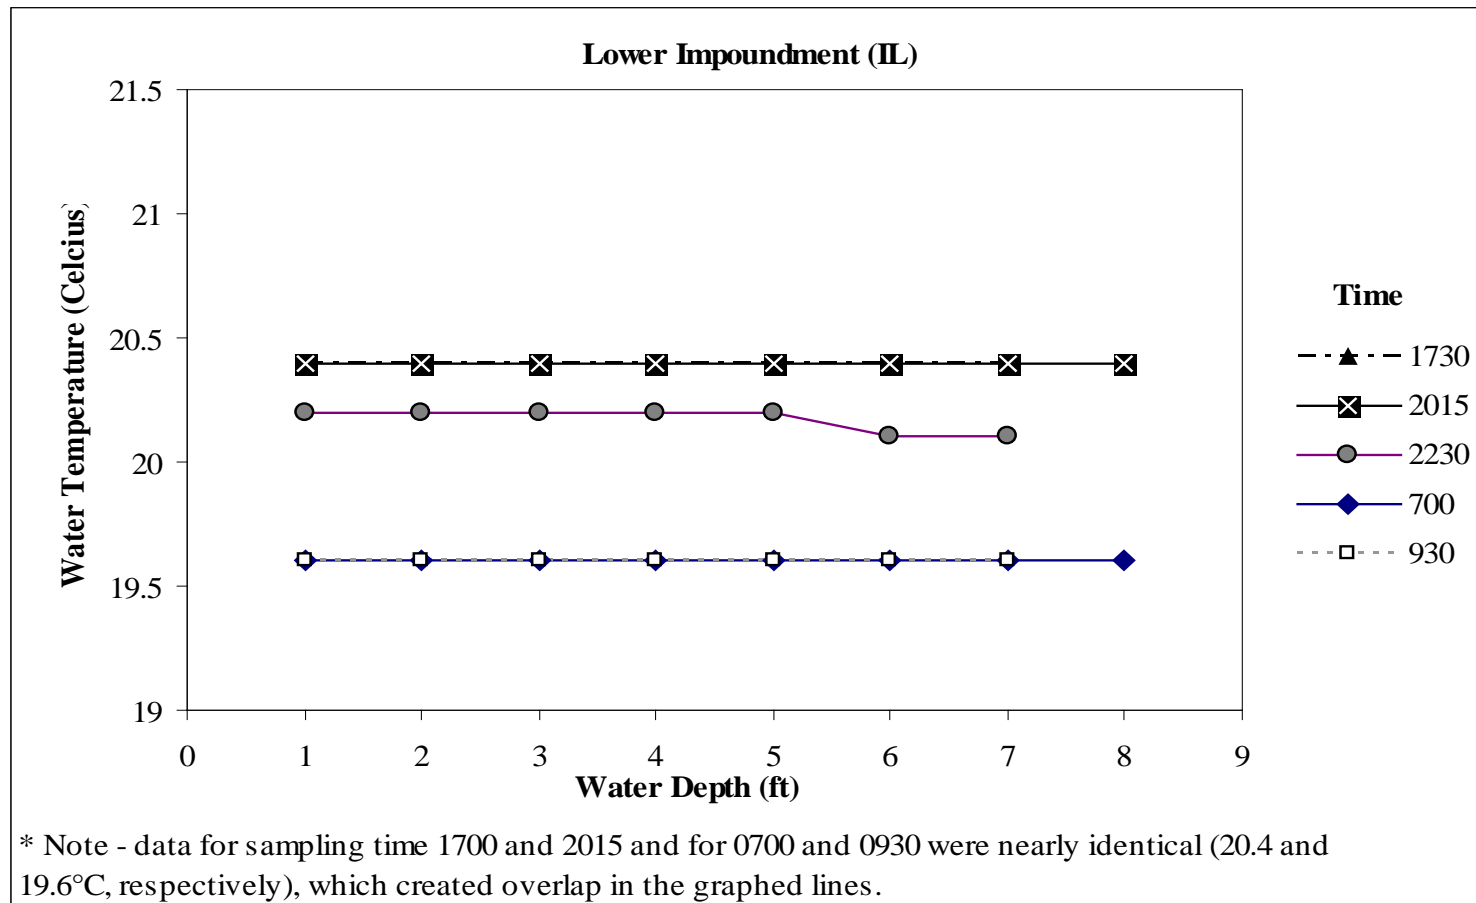
WATER TEMPERATURE BY DEPTH AND SAMPLING TIME IN THE LOWER IMPOUNDMENT

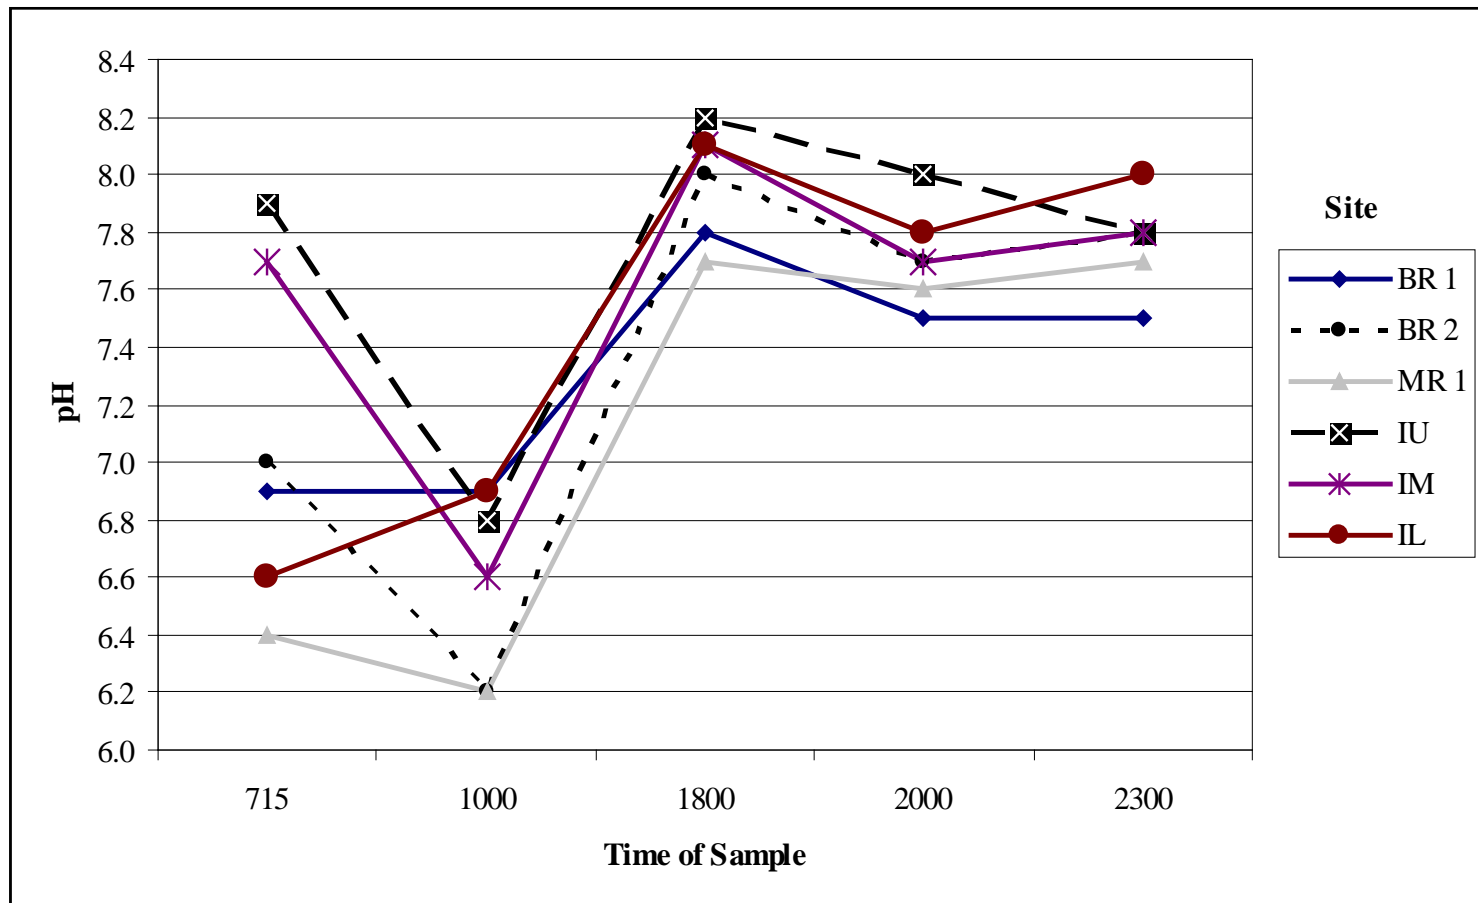
SURFACE pH VALUES FOR ALL SITES
